RE: Teleconference with Formosa Plastics to Discuss Inspections
Photographs (June 15-17, 2010)

REQUEST FOR DOCUMENTS FORMOSA PLASTICS CORPORATION, POINT COMFORT, TX JUNE 15-17, 2010

**Inspection Plan for Formosa Plastics Corporation,
Point Comfort, Texas**

DRAFT TRIP REPORT
FOR
FORMOSA PLASTICS RESIDENTIAL AND AGRICULTURAL
WELL SAMPLING ACTIVITIES
POINT COMFORT, TEXAS

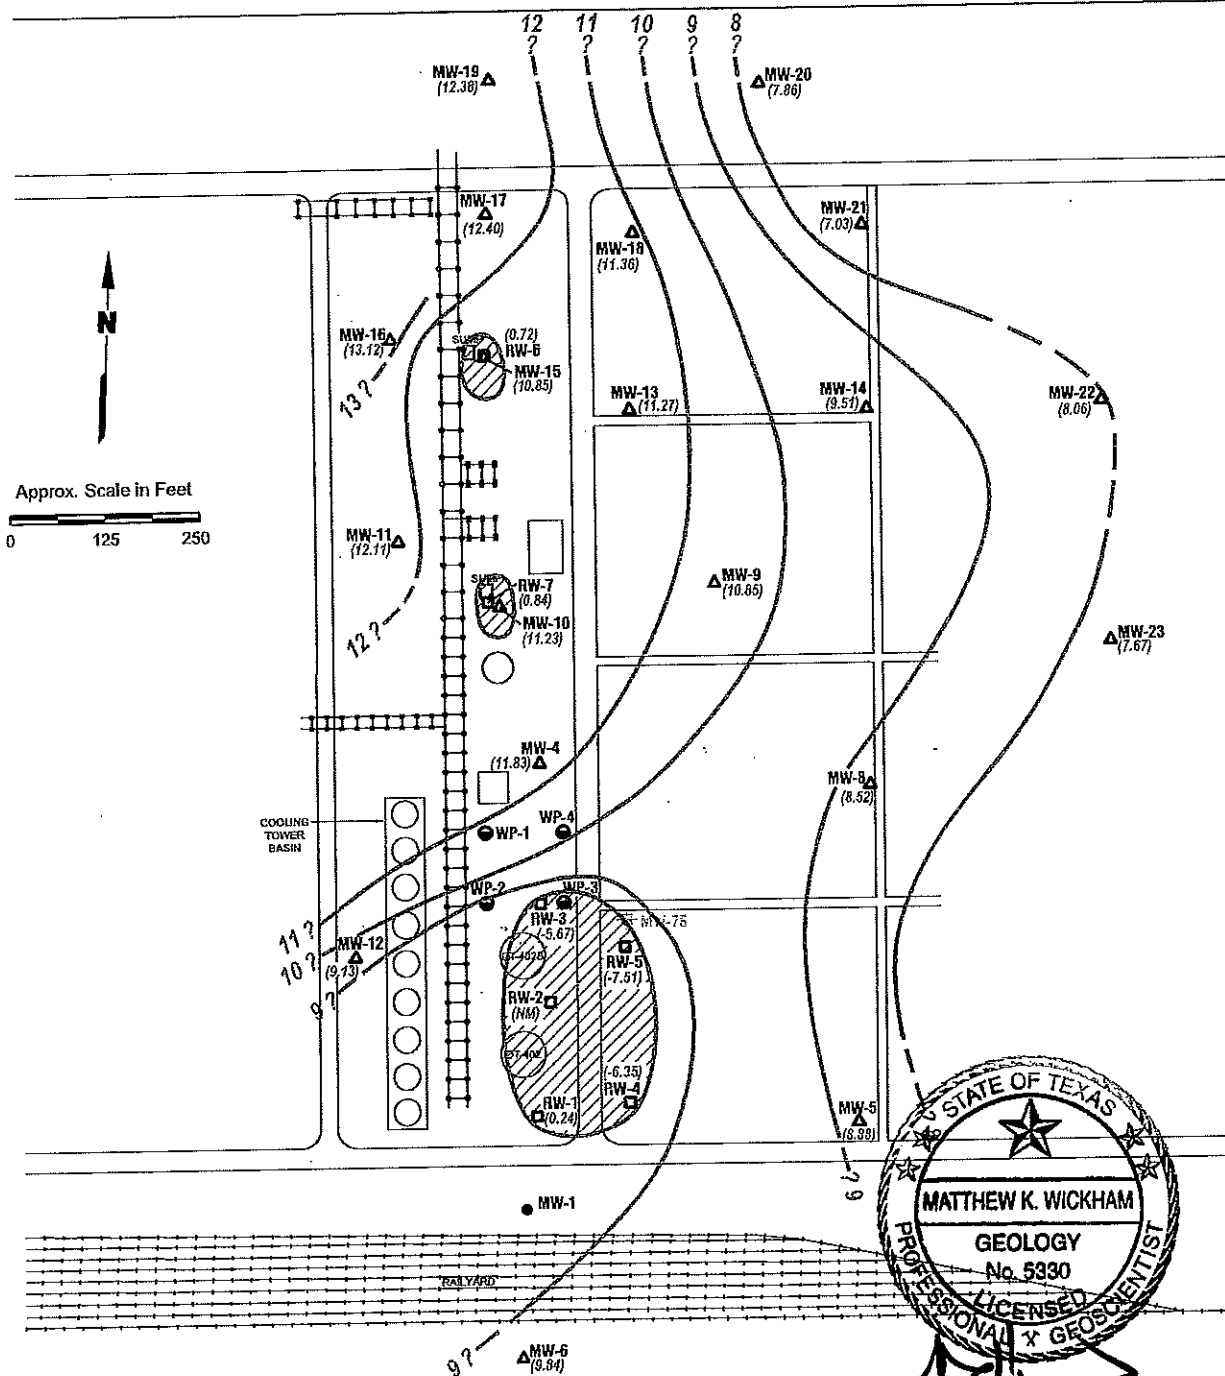
Figure 3

Note:
MW-4 and MW-11 were barricaded during FPC unit work, therefore were not measured this quarter.

POTENTIOMETRIC SURFACE MAP ZONE A - NOVEMBER 3, 2009

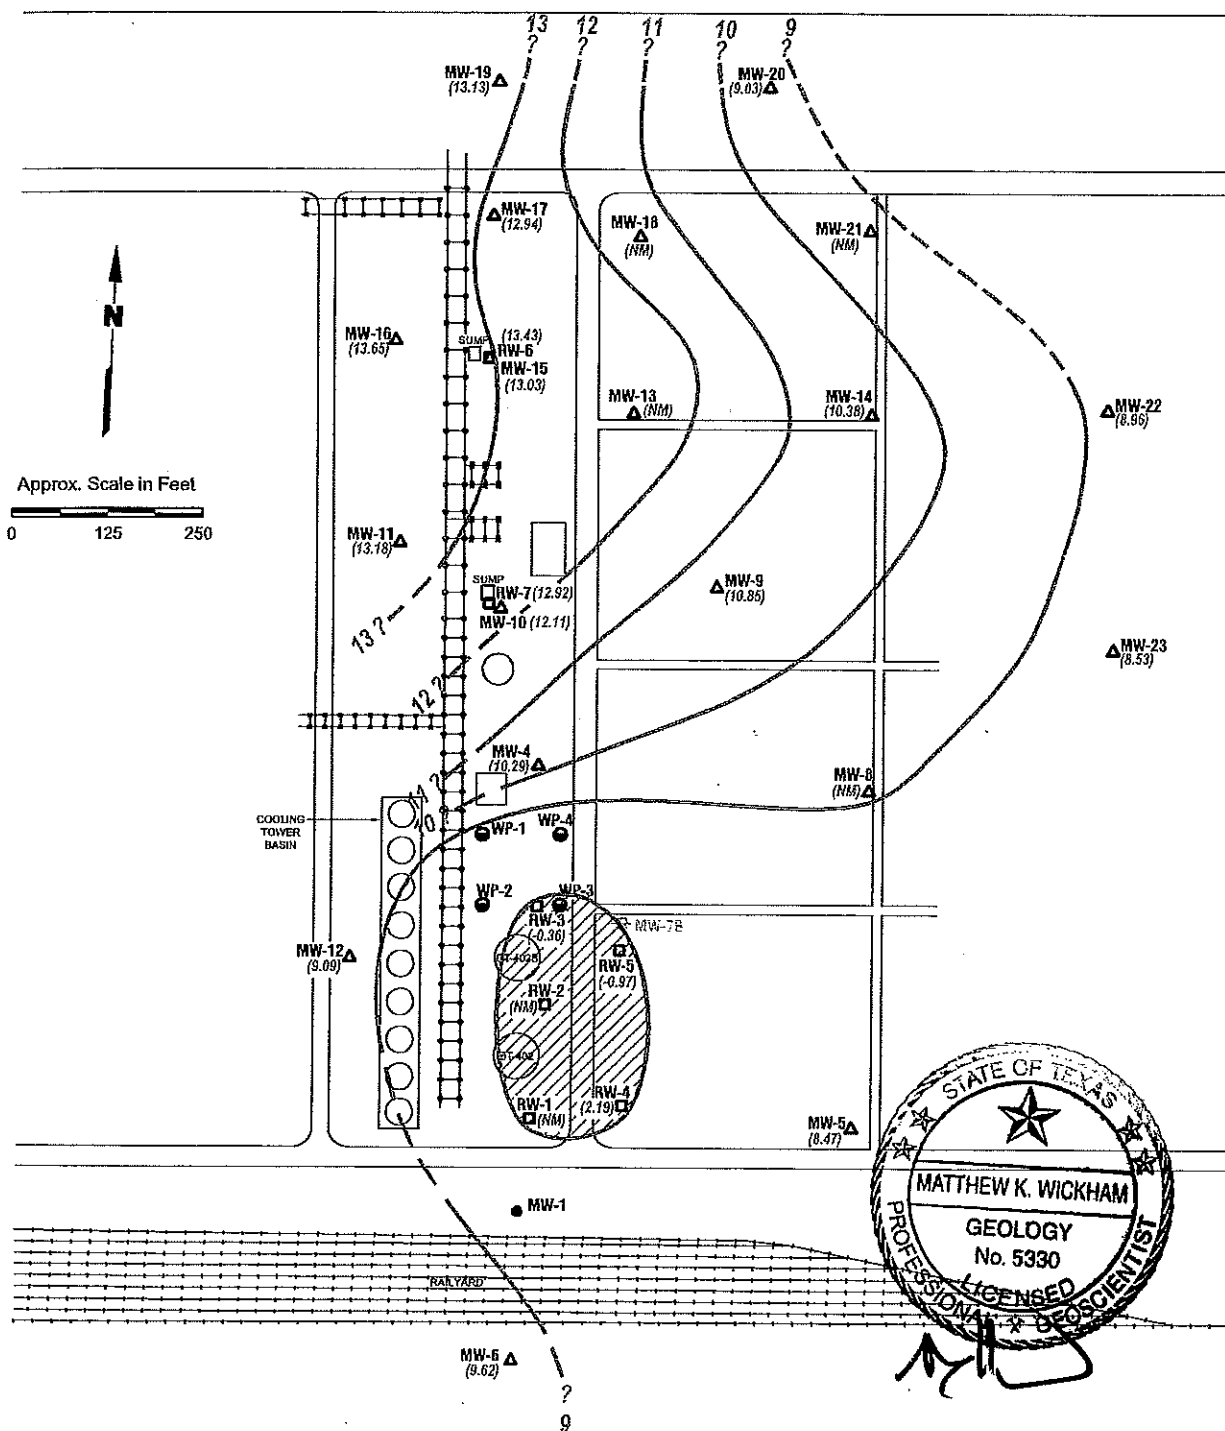
Figure 2

POTENTIOMETRIC SURFACE MAP ZONE A - MARCH 3, 2009

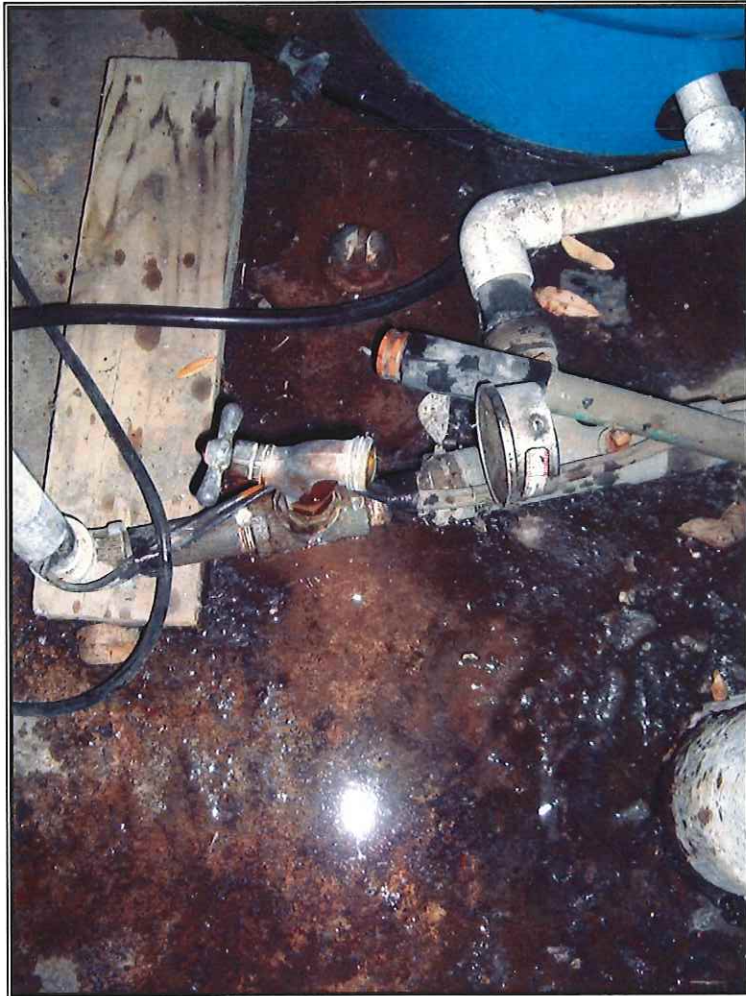
Photo Number: 01

Description: View of sample location for GW-FP-01 and GW-FP-09 (field duplicate) collected from the Woodland residential well

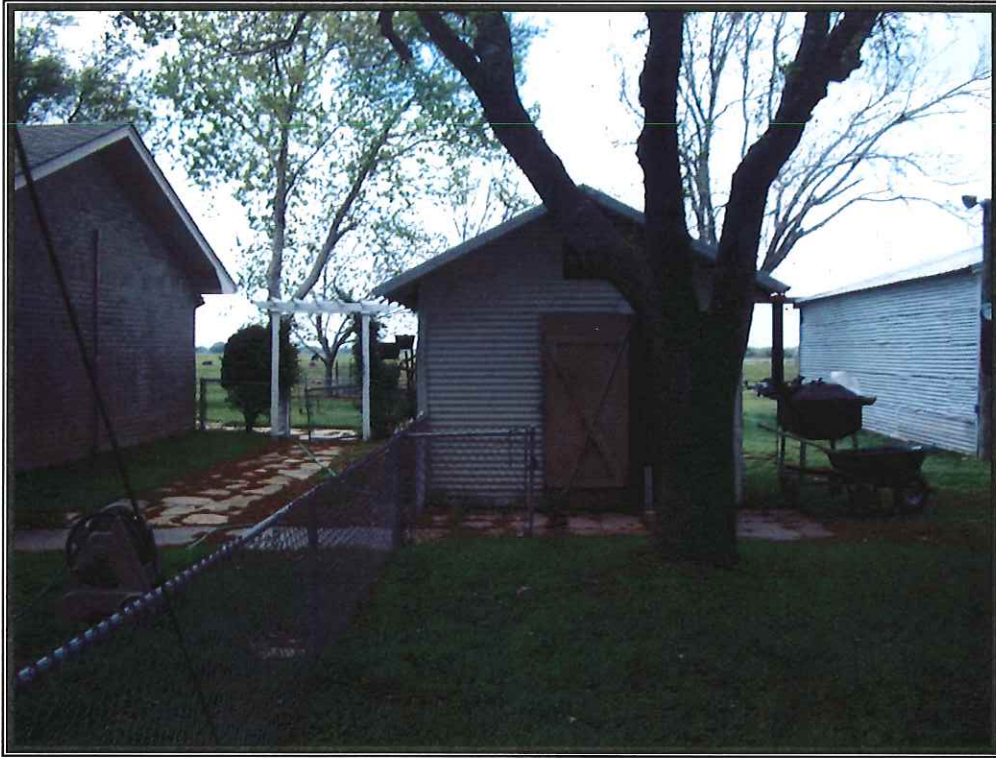
Photo Number: 03

Description: View of the residential well house from which samples GW-FP-01 and GW-FP-09 (field duplicate) were collected

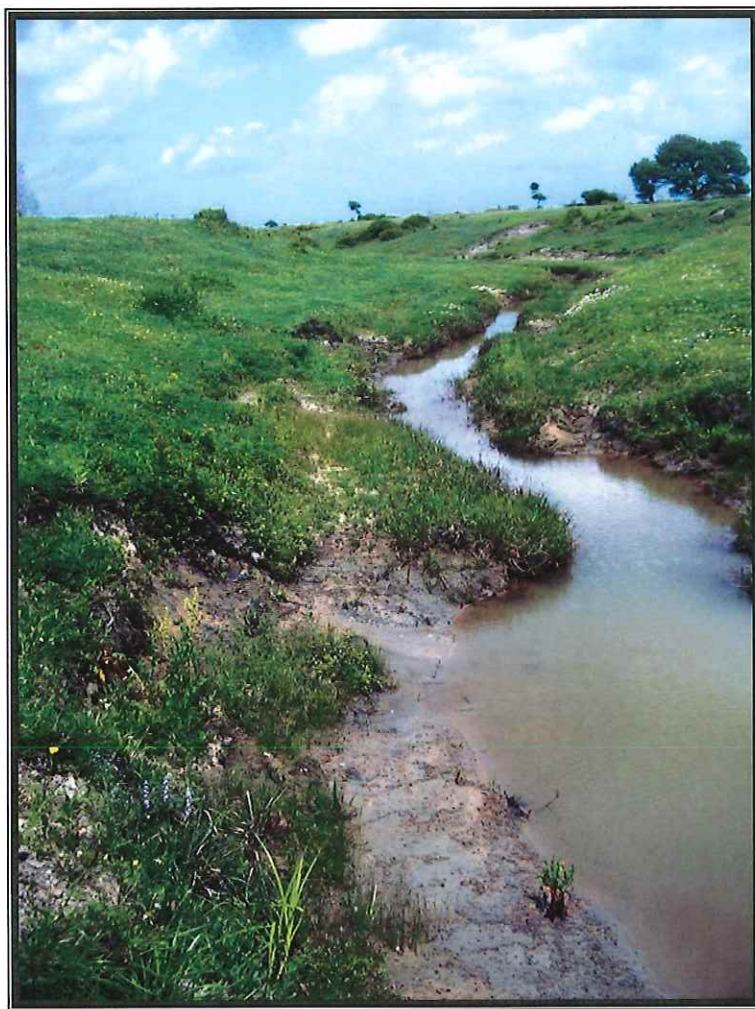
Photo Number: 21 Photographer: Angela Sederquist
Location: Dugger Ranch
Description: View of the seeps in Coks Creek at southern property boundary
City: Port Comfort State: Texas
Date: 04/07/2010 Time: 1252 hours Direction: North
